## LA-UR-19-28813

**Title:** Evaluating Corrosion Effects on the Stainless Steel Components of the SAVY-4000/Hagan Nuclear Material Storage Containers: FY19 Update

**Issued:** 2019-10-11 (rev.1)

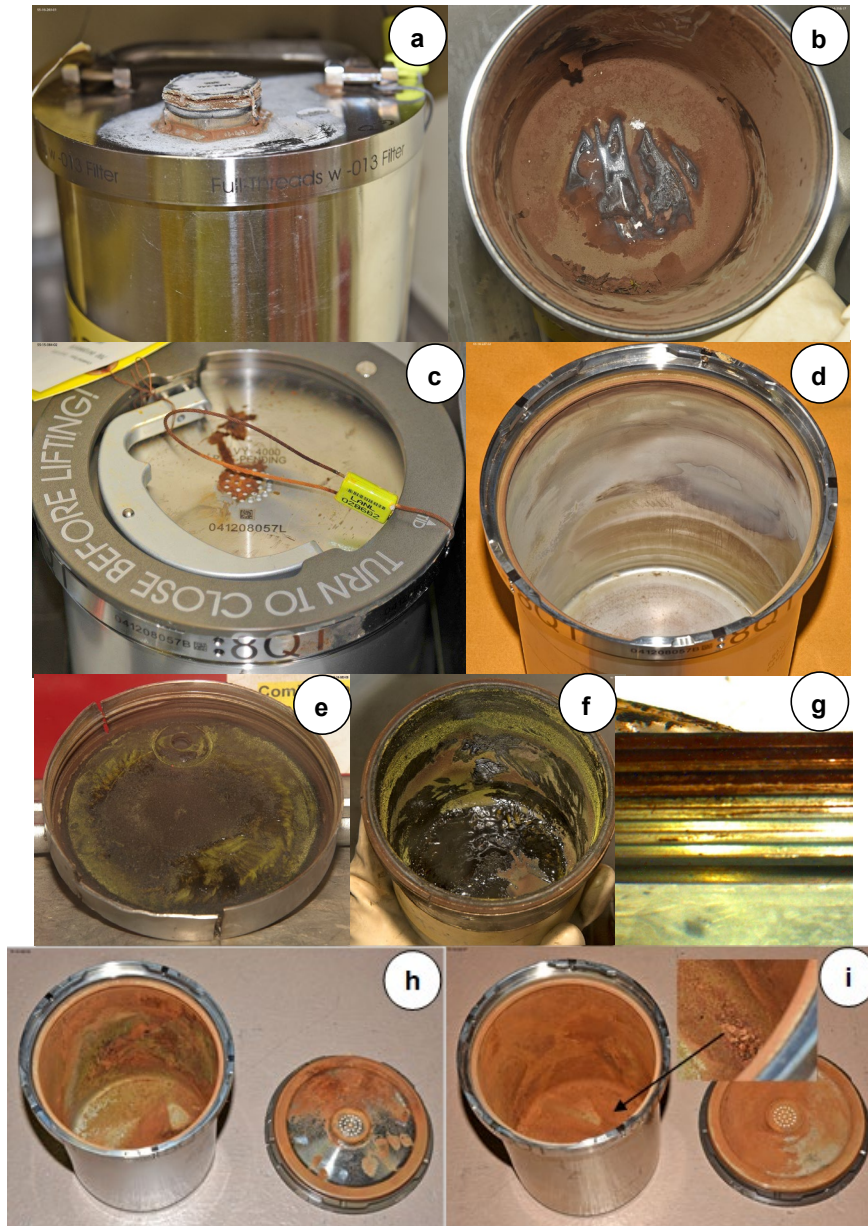
The worst appearing corrosion in any container to date was observed in 18H7 (Figure 1e-g). This container was originally chosen for surveillance in FY17, but surveillance could not be performed because the lid was fused to the body. In the interim, the Hagan was overpacked in a 3-Qt SAVY-4000 container for 14 months. In June 2018, the SAVY-4000 was unloaded, and the Hagan container was introduced into the glovebox line for opening. The lid was removed by making vertical cuts through the threads and prying the side of the lid to separate the threads of the lid from the body.

**Figure 1. Photos of worst corrosion observed to date in SAVY-4000 and Hagan containers based on the visual inspection: (a) 16H1 lid with white powder deposit and corrosion on filter cap, (b) 16H1 inside surfaces have a brown coating, (c) 16S8 has corrosion product deposited on outside of lid from the corroded TID wire above, (d) 16S8 inside surfaces covered in brown and white powders, (e) 18H7 inner surface of lid covered in gummy, green-brown residue, (f) 18H7 inner surfaces of body with gummy, green-brown residue, (g) 18H7 corroded threads, (h) corrosion and loose brown powder on inside surfaces of 20T, (i) corrosion and loose brown powder on inside surfaces of 21T.**

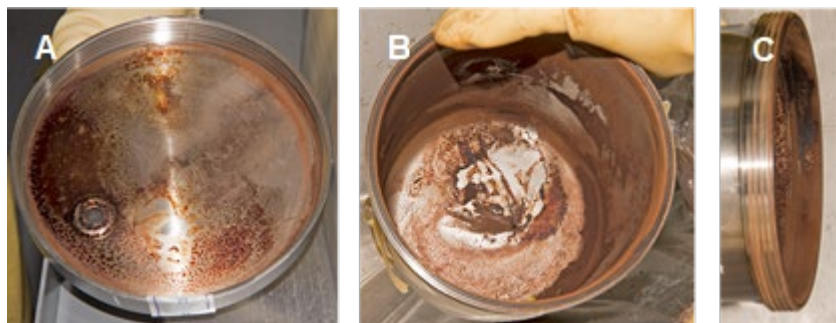
Corrosion was found on six of the eight Hagan containers in FY19. Three Hagan containers were assigned to corrosion group 3 and had corrosion on the threads of the container and lid. Hagan container 19H1 is shown in Figure 2. The container was packaged with a Pu-242 metal item. Contamination was found on the bag out bag, so the entire container was introduced. Sectioning and optical microscopy of this container is planned for FY20.

**Figure 2. Hagan container 19H1 showing corrosion on lid (A), body (B), and the threads (C). Corrosion product powder was observed at the bottom of the container (B).**

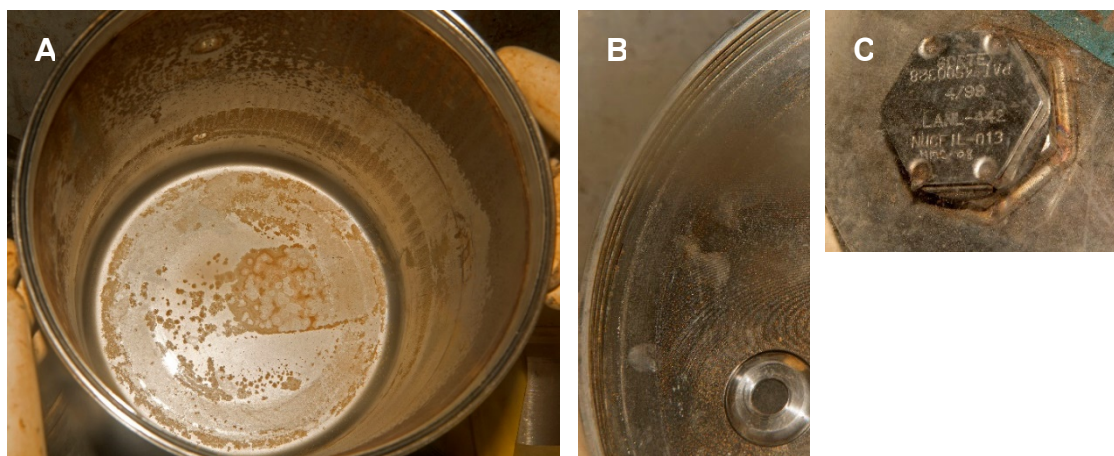
Hagan container 19H3 is shown in Figure 3. The container was packaged with a Pu-238 incinerator ash item. The entire container was introduced. Corrosion was found throughout the container as well as on the container threads and the outside of the filter.

**Figure 3. Hagan container 19H3 showing corrosion on lid (A), body (B), and the threads (C).**

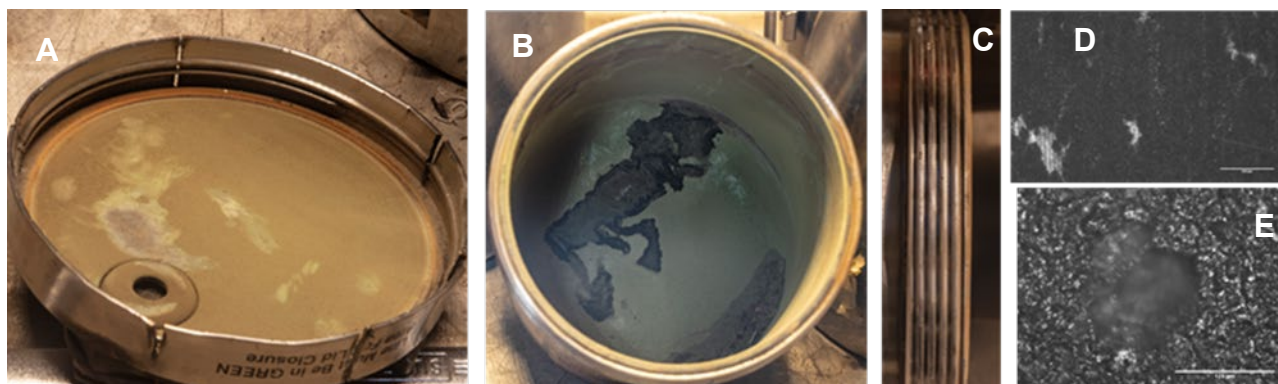
Hagan container 19H5 was selected for surveillance based on its similarity to container 18H7, which was the worst-appearing Hagan container observed to date. Details on container 18H7 are given in Figure 1e-g and Table 2. Both containers were 1-Qt Hagan containers packaged with MSE salt material. The conditions inside container 19H5 are shown in Figure 4. Similar to container 18H7, the lid of 19H5 was fused to the body due to corrosion. Therefore, the container was introduced into the glovebox line where it was opened by cutting. This container had heavy deposits of a brown powder covering the inside surfaces of the walls and lid and collected at the bottom of the container. The powder was removed from the container by brushing. The container was weighed before and after brushing and showed a weight difference of 4.2 grams due to removal of the powder. The identity of the powder was not determined but is believed to be mixture of stainless steel corrosion product and degradation product of the PVC bag. Optical microscopy was performed on sections of the cleaned container lid and body. The lid shows mostly general corrosion and shallow pits. The pit diameters could not be determined because much of the native surface was removed (Figure 4D). The container walls had large, agglomerated pits approximately 100 to 150  $\mu\text{m}$  in diameter (Figure 4E).

**Figure 4. Hagan container 19H5 showing corrosion on lid (A), body (B), and the threads (C). Optical microscopy images show general corrosion (D) and pitting (E).**

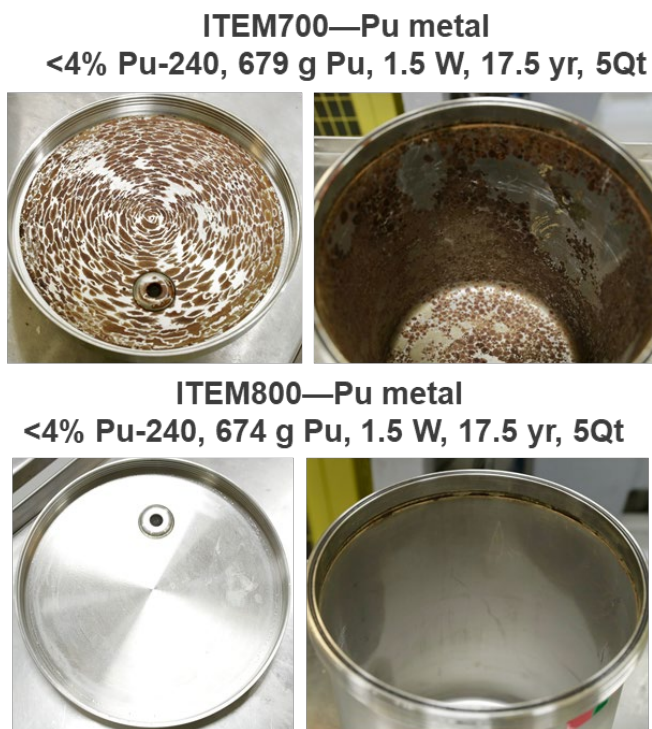
Two Hagan containers selected for surveillance in FY19 were both packaged about 17.5 years ago with identical contents in the same size Hagan containers. The history of their storage locations is not known at this time, but the items were retrieved from different shelf locations in the same PF4 vault room at the time of surveillance. Despite being packaged with the same contents, the two containers showed different corrosion behavior. Container 19H7 had spots of corrosion throughout the container giving the appearance of liquid droplets that had formed and later dried. Container 19IoOP50 only had corrosion in the weld region and bag residue on the container bottom.

**Figure 5. Comparison of 19H7 (top) and 19IoOP50 (bottom) packaged with identical content but stored in different vault locations.**

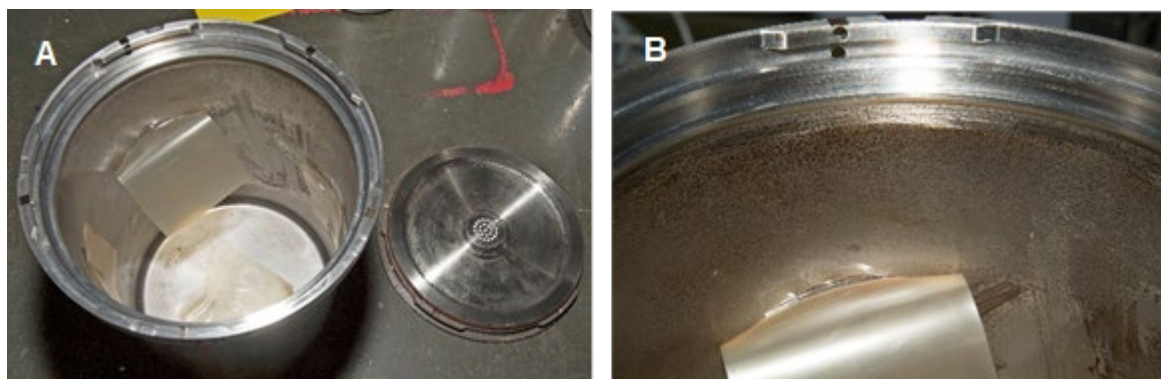
Corrosion was found on five of the ten SAVY-4000 containers that had surveillance performed to date in FY19. The worst appearing containers were 19S1 and 19S13. The SAVY-4000 container 19S1 packaged with BLO-39-11-16 is shown in Figure 6. Corrosion is present throughout the container and heaviest in the region surrounding the weld. Surveillance has been performed on this container each year since FY17, and little change has been observed in the severity over that time frame (Figure 7). Samples of APU bag out bag material were placed inside the container in FY18 to test the behavior in a storage container. Because the samples were placed outside of the PVC bag out bag, they were exposed only to the thermal heat of the package and gamma dose. After one year, the bag samples show only slight yellowing.

**Figure 6.** SAVY-4000 container 19S1 packaged with BLO-39-11-16. This container has spots of corrosion throughout the inside of the body and lid. Samples of the APU bag that were placed inside in FY18 show a slight yellowing.

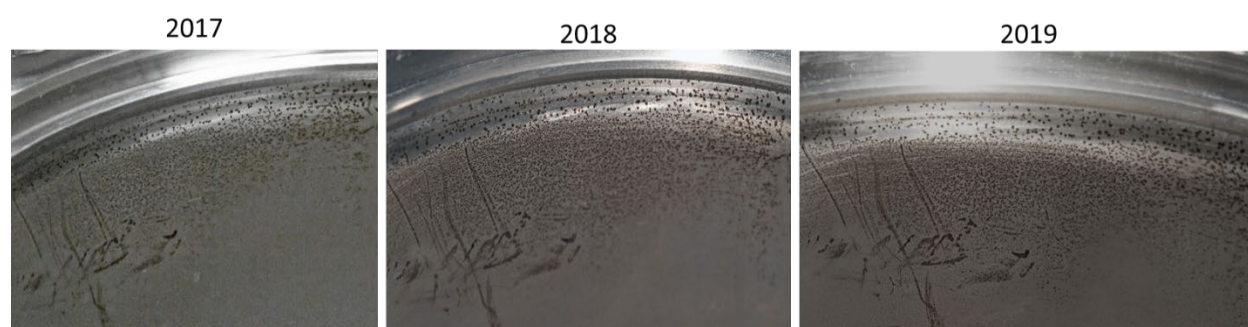
**Figure 7.** SAVY-4000 container 19S1 packaged with BLO-39-11-16 had surveillances performed in FY17, FY18, and FY19. Little change has been observed since FY17.

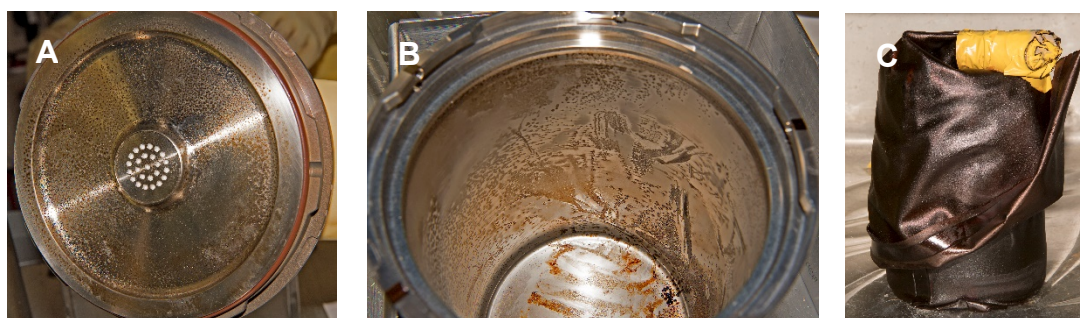
SAVY-4000 container 19S13 was packaged with an oxide material high in Pu-240 ( $16.00 < 19.00\%$  Pu-240). Materials high in Pu-240 tend to be higher in Am-241, which increases the gamma dose to the PVC bag. As shown in Figure 8, the container has spots of corrosion on the lid and body as well as evidence of liquid residue and/or staining from the degradation of the bag. The bag was dark, but pliable. Due to concerns that the bag could fail during the next storage interval, a second PVC bag was added to the package.

**Figure 8.** SAVY-4000 container 19S13 showing corrosion on lid (A), body (B), and the dark-colored PVC bag out bag.

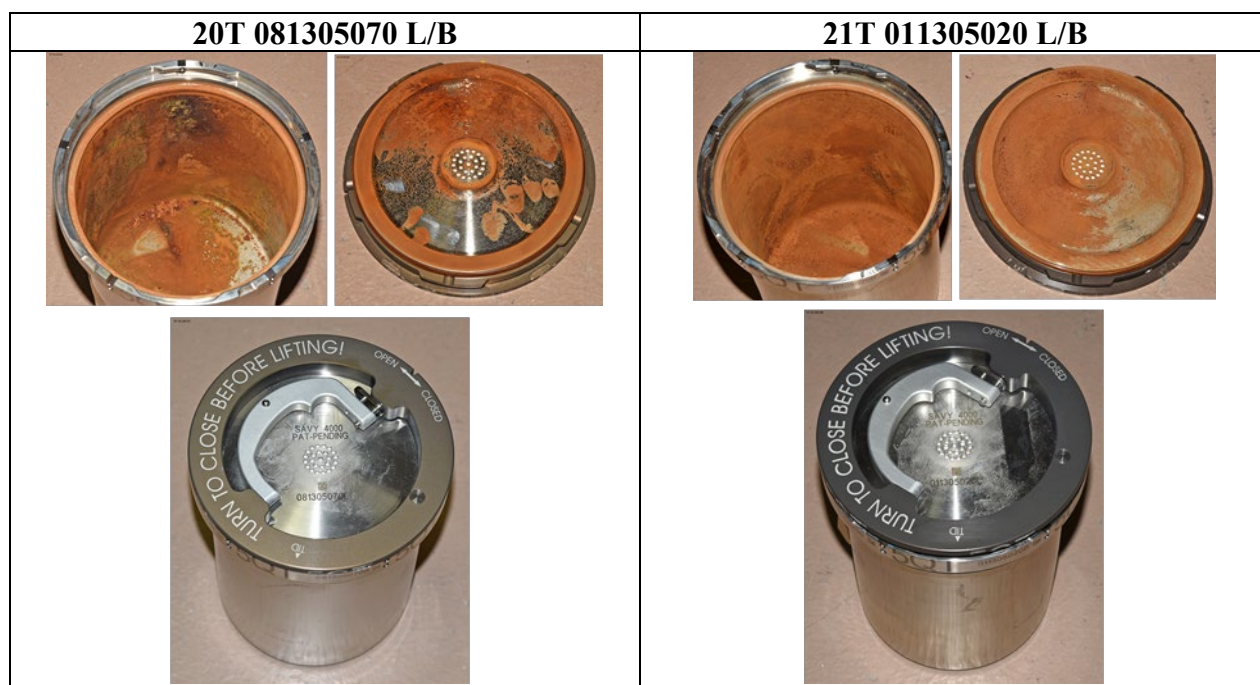
Photographs of the containers (Figure 15) show general corrosion after 14 months of use. Loose brown powder was found in the bottom of the container.<sup>8</sup> The exterior surface of the container lids had a deposit of white powder surrounding the filter. Samples of the brown and white powders were collected from each container. The brown powder collected from each container was weighed and found to have a mass of 1.9 grams. The remaining corrosion product was removed using Fantastik® cleaner on a piece of cloth. The cleaning did not require scrubbing and wiped clean.

**Figure 15. Photos of SAI containers taken in FY16 for surveillance.**

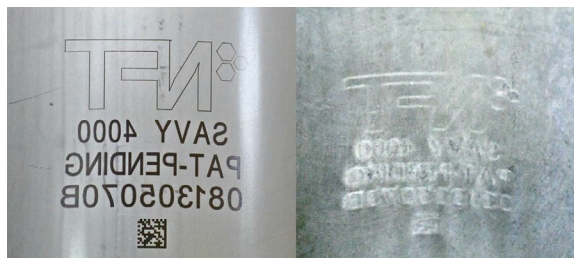
After cleaning the container, the laser etching was visible on the inside of the container wall (Figure 16). It appears that the laser etching caused a heat affected zone that, when exposed to HCl gas inside the container, caused a different corrosion effect in that area. Samples of the heat-affected zone were tested by exposing samples to  $\text{FeCl}_3$ , but the tests found no evidence that laser etching increased the susceptibility of the reverse side of Hagan or SAVY-4000 pieces when exposed to  $\text{FeCl}_3$ .

**Figure 16. Image of laser etching on inside of container wall.**

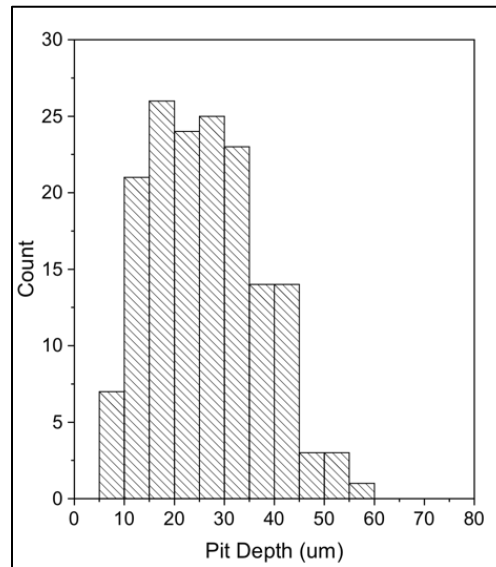
Examination of the height data collected on the surface of the SAI sample (Figure 19c) found pitting with a pit depth distribution ranging between 5 and 60 microns (Figure 20). The region with the highest density of pits is located near the weld, as shown in Figure 19.

**Figure 20. Pit depth statistics of SAI section.**

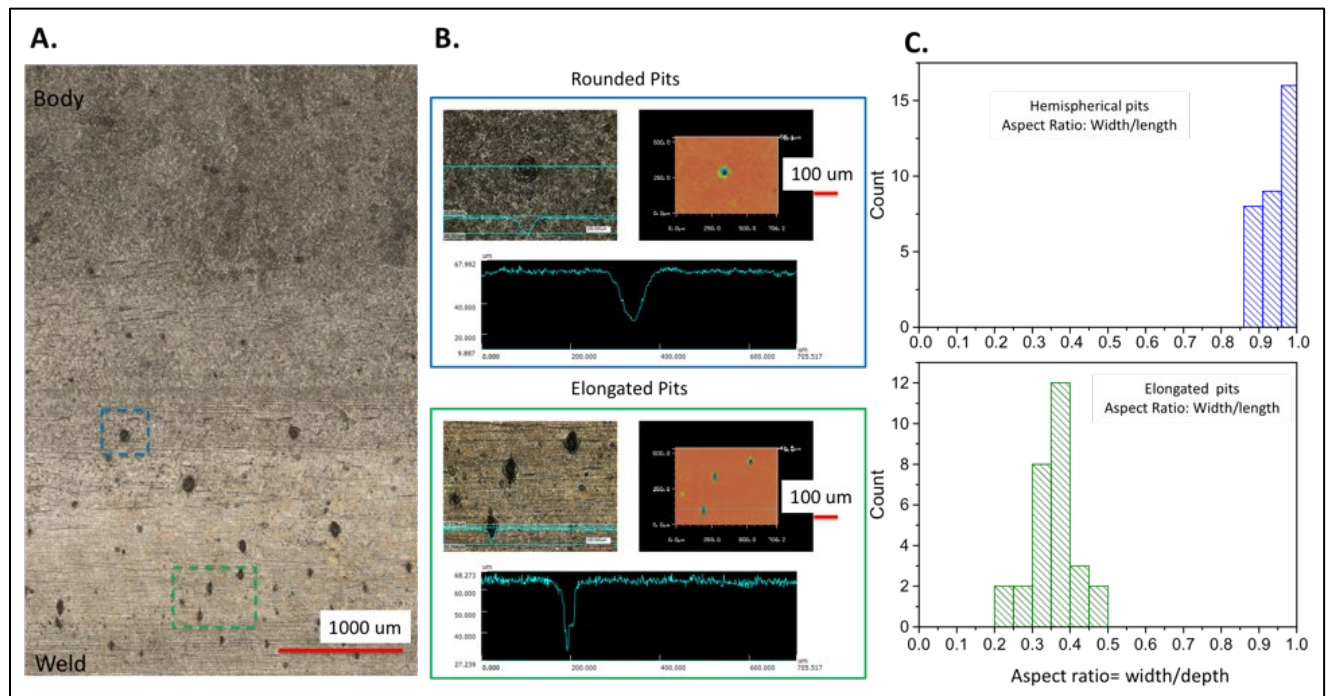
Close examination of the pits shows that the pits further from the weld were round in shape while the pits nearest to the weld were elongated in the vertical direction. Figure 21 shows some representative profiles for rounded and elongated pits. The aspect ratio between the width and length of round pits shows a value close to one while the aspect ratio for elongated pits is less than 0.5 (Figure 21d).

**Figure 21. A. Representative optical image of different pits. B. Height profile for rounded pits and elongated pits. C. Histogram of the aspect ratio between the width and length of the pits for rounded and elongated pits.**

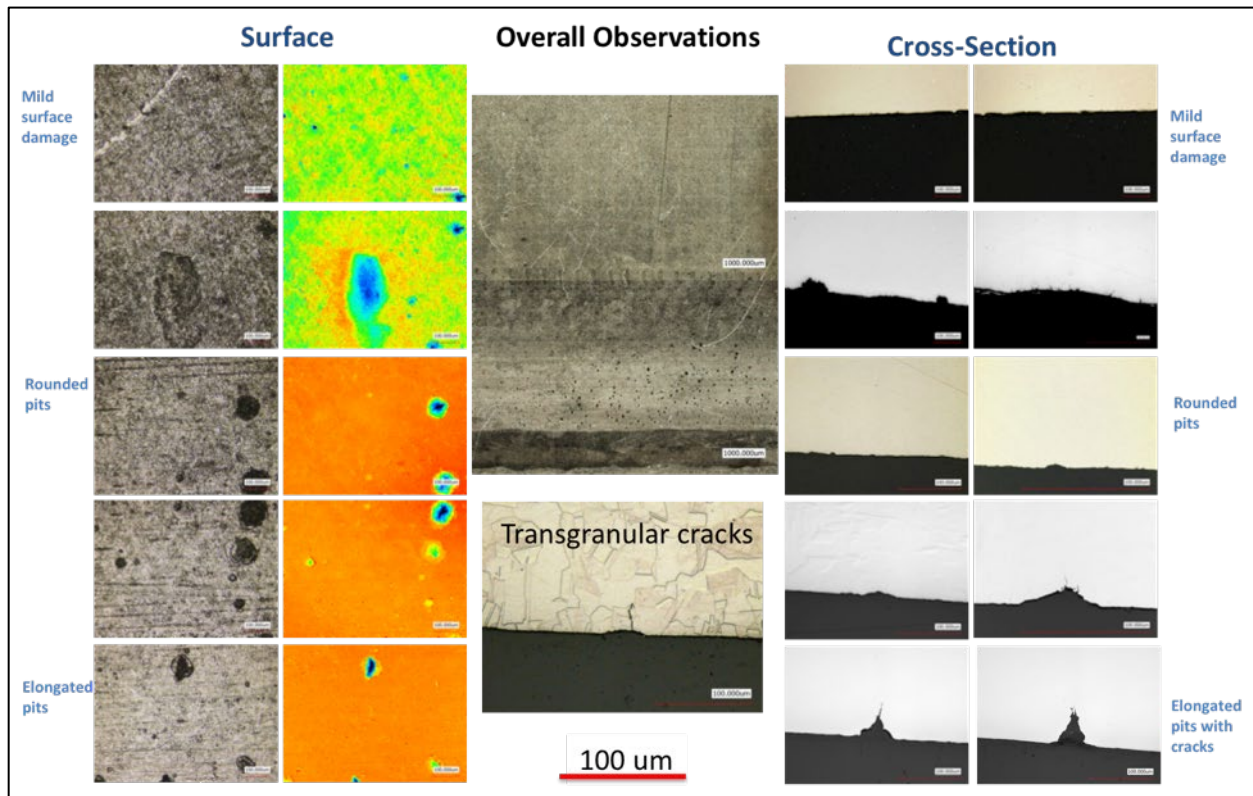
density of rounded pits was observed. At approximately cross section sample 6, the pits become elongated in shape. The elongated pits have a triangle-like shape with small cracks at the bottom of the pits. The cracks are transgranular in nature. No through-wall cracks were found.

**Figure 23. A. Representative images of the surface and cross-sections at different cross-section points. All images collected with LCM instrument.**

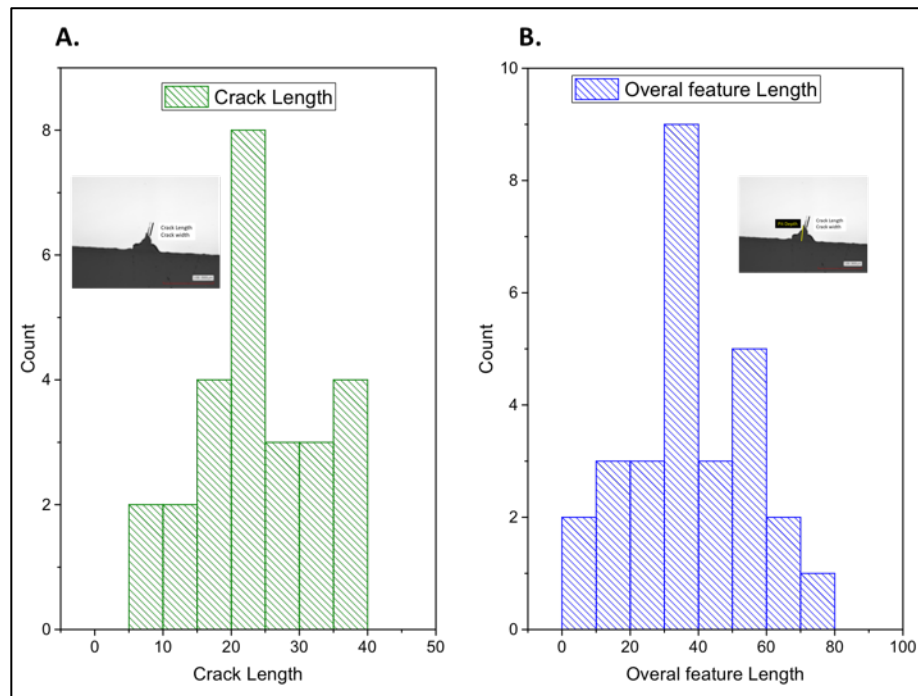
The distribution of the crack lengths (measured from the bottom of the pit) and feature lengths (pit plus crack) was obtained. The distribution shows that the crack lengths range from 5 to 40 microns long while the depth of the overall features ranges from 5 and 80 microns (Figure 25). The maximum depth of the overall features is approximately 10 percent of the SAVY-4000 container wall thickness.

**Figure 25. A. Histogram of the crack lengths from the bottom of the pits. B. Histogram of the entire feature length, pit plus crack.**

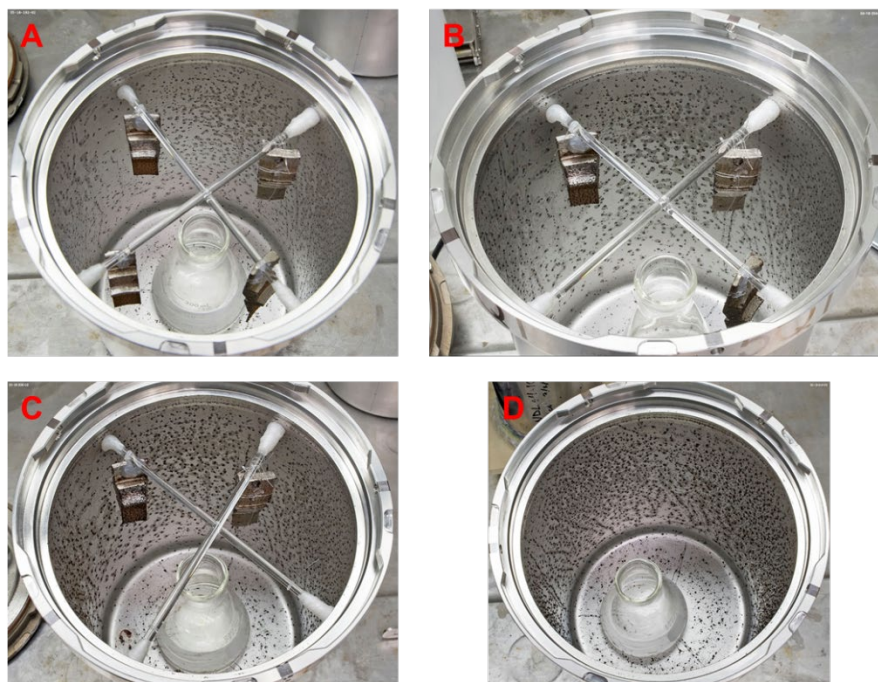
**Figure 27. Photographs of SAVY-4000 storage container after exposure to the vapors from 6.0M HCl for 31 (A), 63 (B), 95 (C), and 126 (D) days. Photographs show an increase in corrosion density on the container wall with increased exposure time. Similar corrosion behavior was observed on the container lid (photographs not shown).**

For the SAVY-4000 container, an increase in corrosion density was measured on the container wall with increasing exposure time. The corrosion is isolated to corrosion “islands” and does not cover the entire surface of the container, and it is not greater at the weld area. Similar corrosion was also observed in the exposure of teardrops (stainless steel samples) to 6.0M HCl vapors.<sup>20</sup> The corrosion observed on these SAVY-4000 container test specimens is shown in Figure 29. These samples also have isolated corrosion “island” and general corrosion covering the entire surface of the sample, which was not observed on the container wall. Surface analyses after cleaning found surface corrosion and uniform pitting on the entire surface of these samples (Figure 30). Increasing exposure time to HCl vapors did not significantly result in an increased number of pits on these samples, and only a small increase in pit depths was measured.

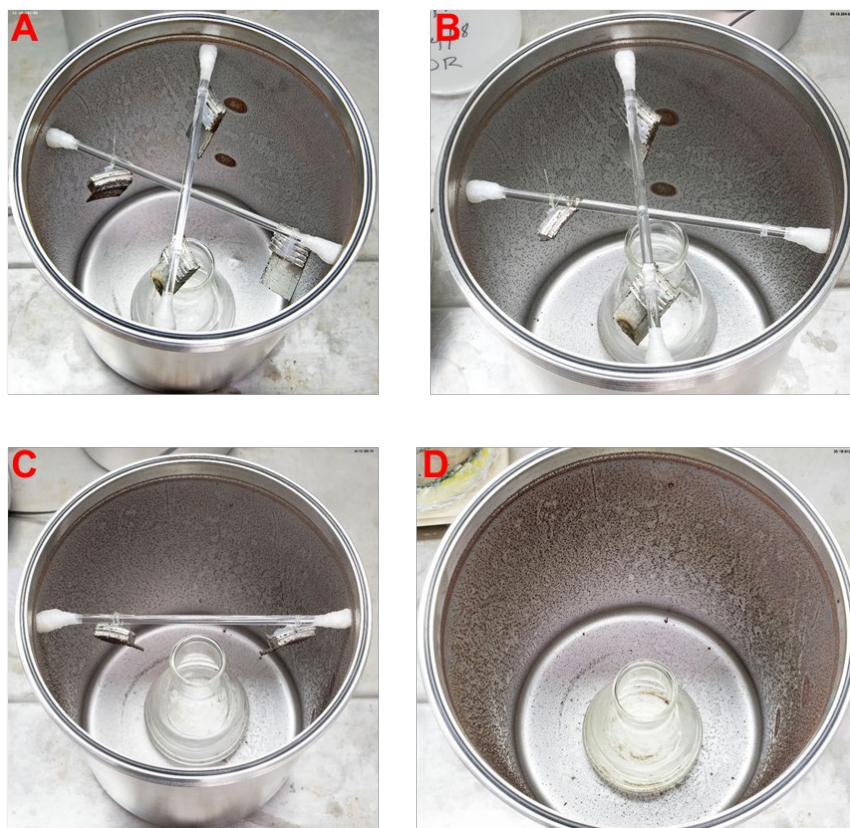
**Figure 28. Photographs of Hagan storage container after exposure to the vapors from 6.0M HCl for 31 (A), 63 (B), 95 (C), and 126 (D) days. Photographs show an increase in corrosion density on the container wall with increased exposure time. Similar corrosion behavior was observed on the container lid (photographs not shown).**

Similarly, a Hagan container and four corrosion specimens were exposed to the vapors from 6.0M HCl. The photographs show an increase in corrosion density on the container wall with increasing exposure time. The corrosion is also isolated to corrosion “islands” but in this case, there is more surface coverage compared to the SAVY-4000 container. Surface analyses by LCM on the container wall are currently ongoing. The Hagan container test specimens showed similar corrosion to what was observed on the container (Figure 31). Surface analyses after cleaning found surface corrosion, and pitting on all of the samples, with corrosion cracks observed on the samples removed after 95 and 126 days of exposure. The pits and cracks were observed in the heat-affected zone (Figure 32). Increasing the exposure time in these samples increased the number of pits, and the pit depths as shown in Figure 33.

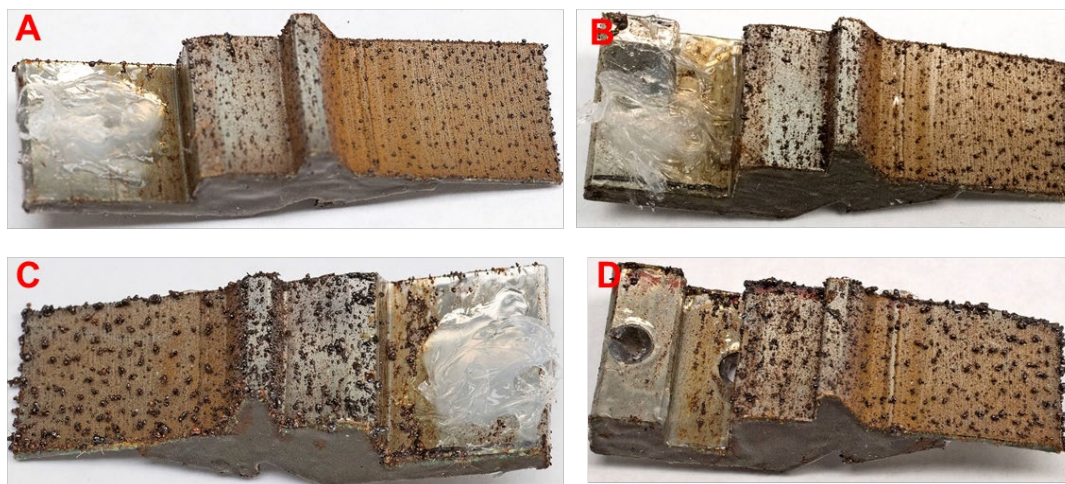
**Figure 29. Photographs of SAVY-4000 corrosion specimens after exposure to vapors from 6.0M HCl for 31 (A), 63 (B), 95 (C), and 126 (D) days. Photographs show the presence of corrosion “islands”, present in the container, and general corrosion. The latter was not observed on container walls.**

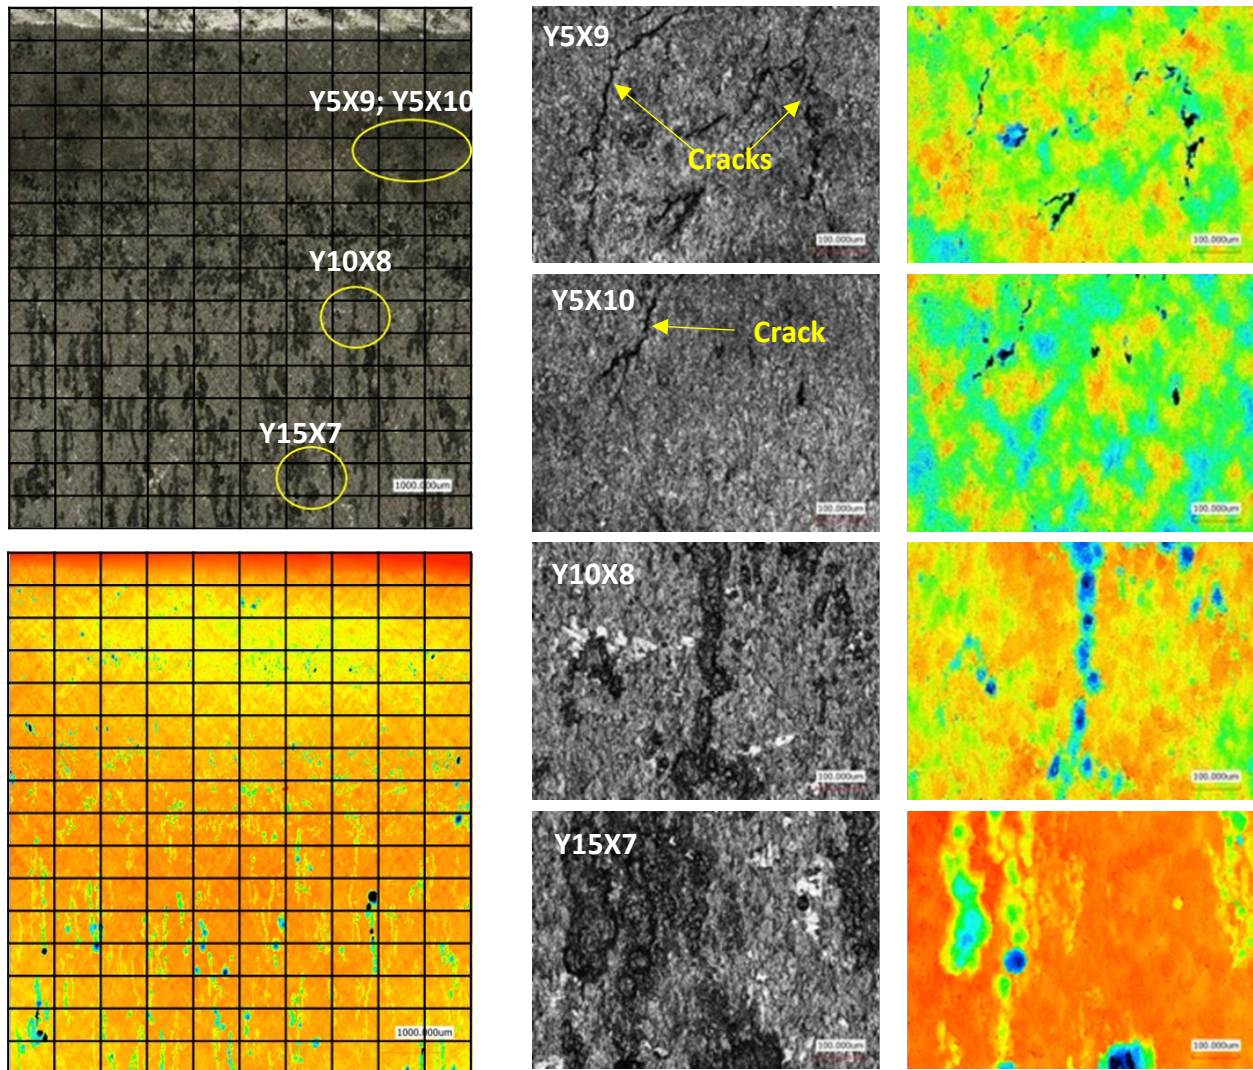
**Figure 32. Representative optical stitched (top left) and height stitched (bottom left) images (10x16) of Hagan corrosion specimen exposed to vapors from 6.0M HCl for 126 days. Optical (middle) and height (right) images show the presence of cracks (Y5X9; Y5X10) and pits (Y10X8; Y15X7) on this sample.**

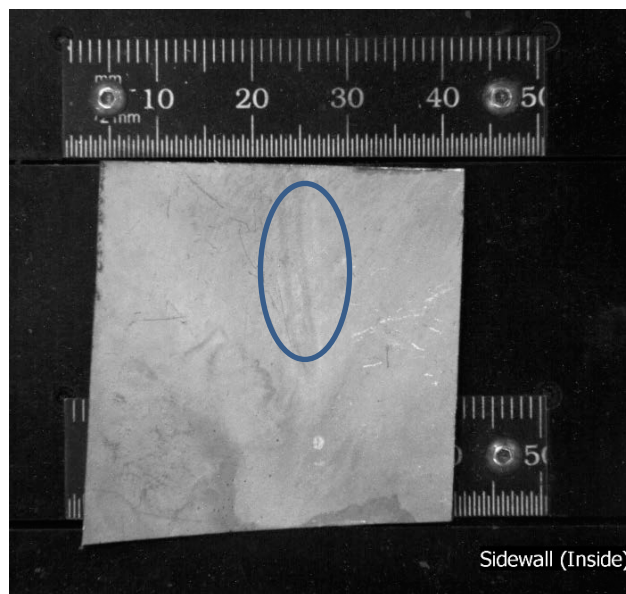
**Figure 37. Sample cut from Hagan container 16H1. Pitting was located in the region where the bag was in contact with the wall (blue oval).<sup>9</sup>**

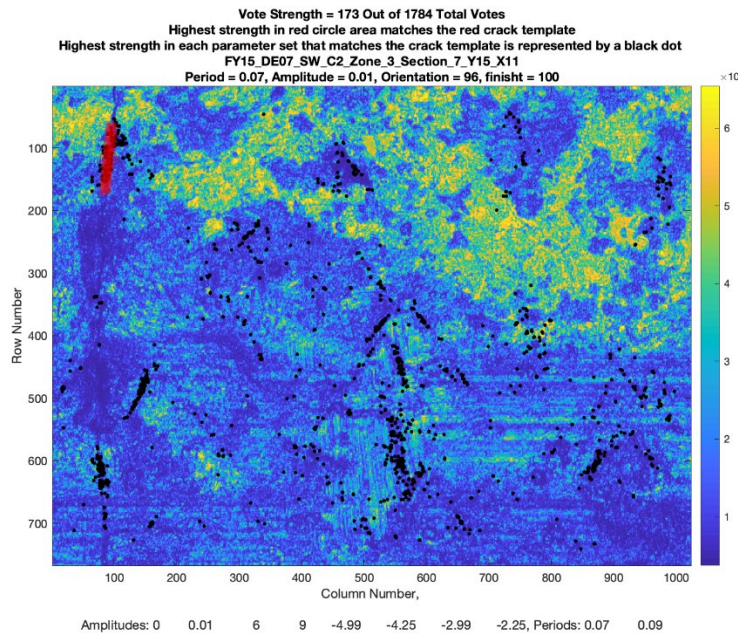
**Figure 42. Identified potential crack, red line, on a piece from a 3013 container.**
